***MASCUPPIC LAKE DAM***  
**PHASE I**  
**INSPECTION / EVALUATION REPORT**

Dam Name: Mascuppic Lake Dam

NID ID#: MA01225

Date of Inspection: October 15, 2020

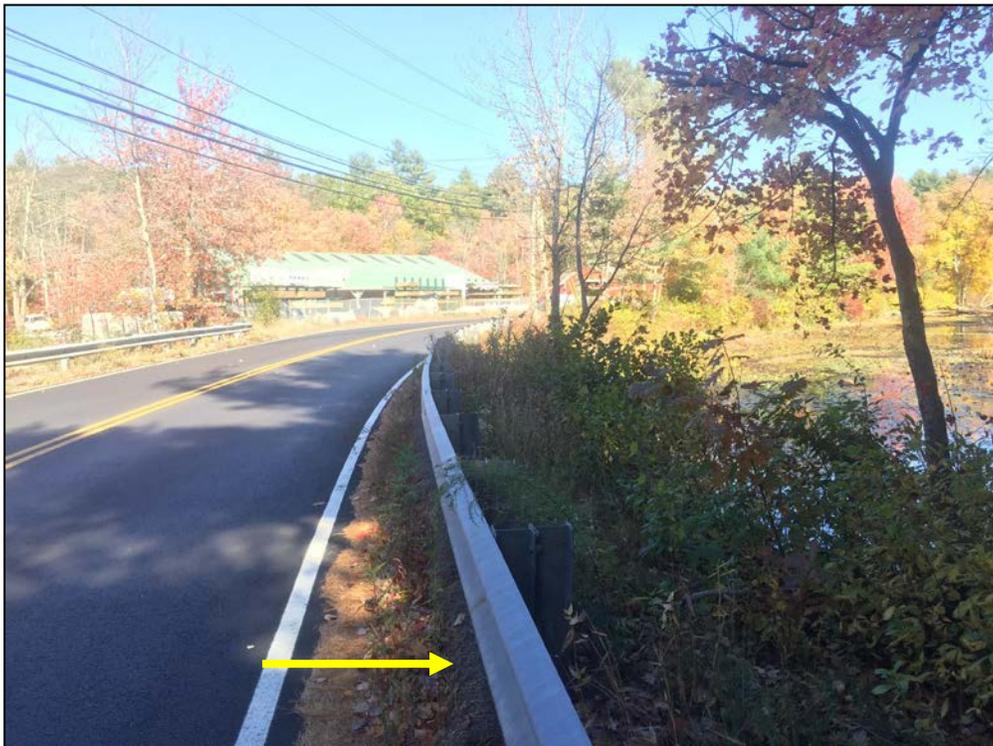
Photo No. 4: Upstream slope looking right at STA 0+50. Note the sediment control sock next to the guardrail.

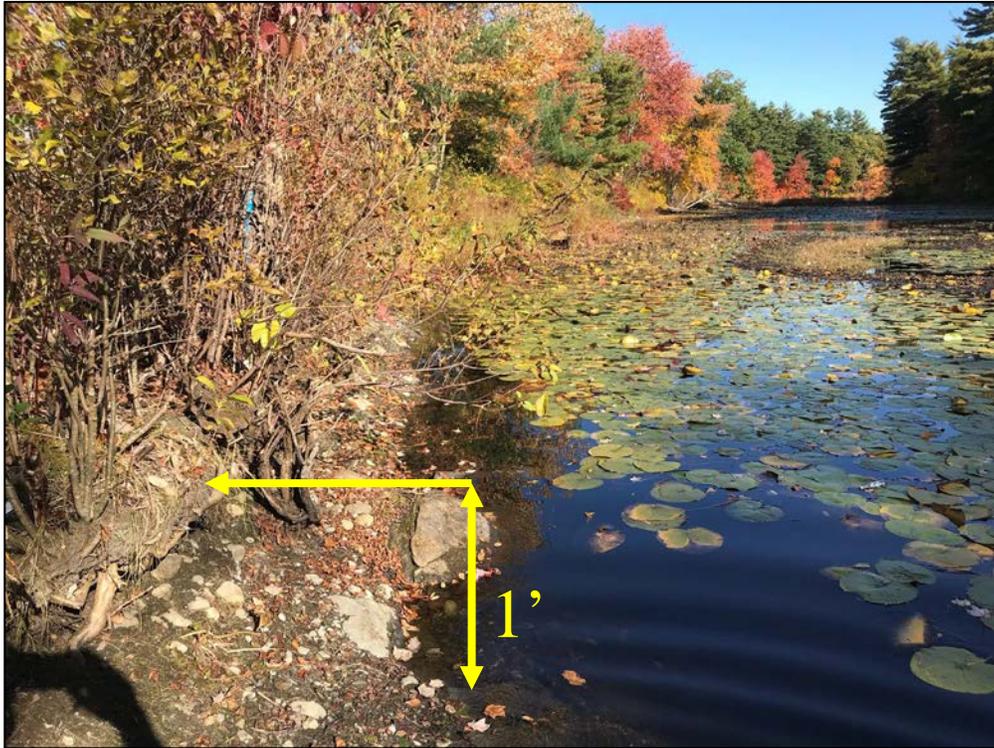
Photo No. 9: Upstream slope at STA 1+35 looking right. Scarping up to 1 was estimated on the upstream slope.

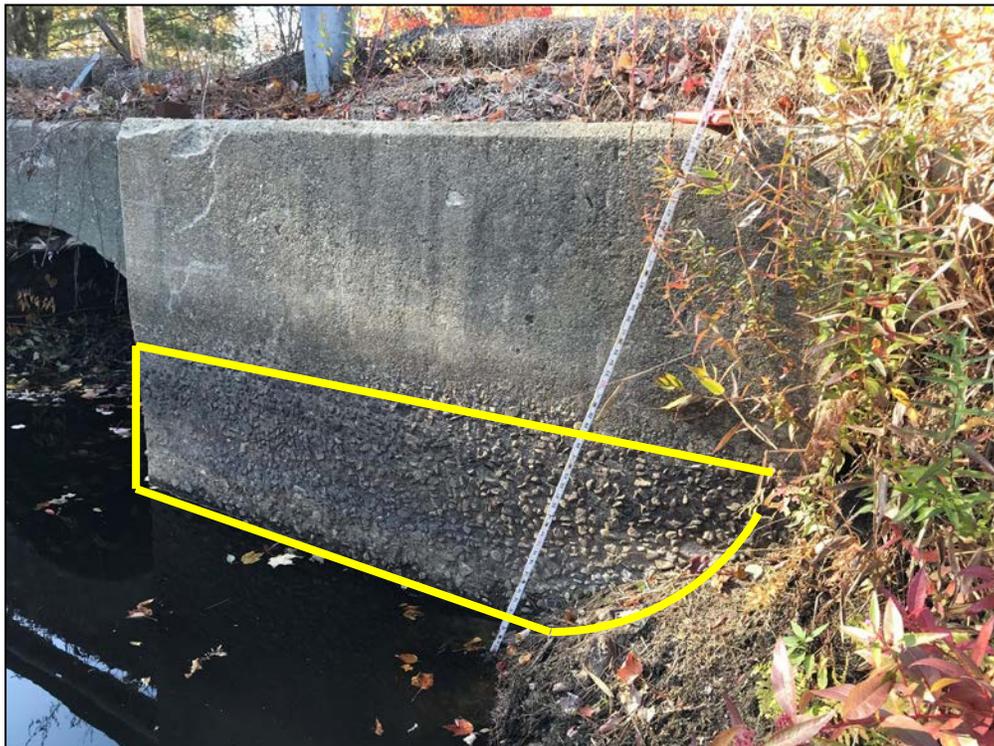
Photo No. 10: Left Outlet: Abrasion observed on right side of concrete headwall extending 3 feet above current pool elevation.

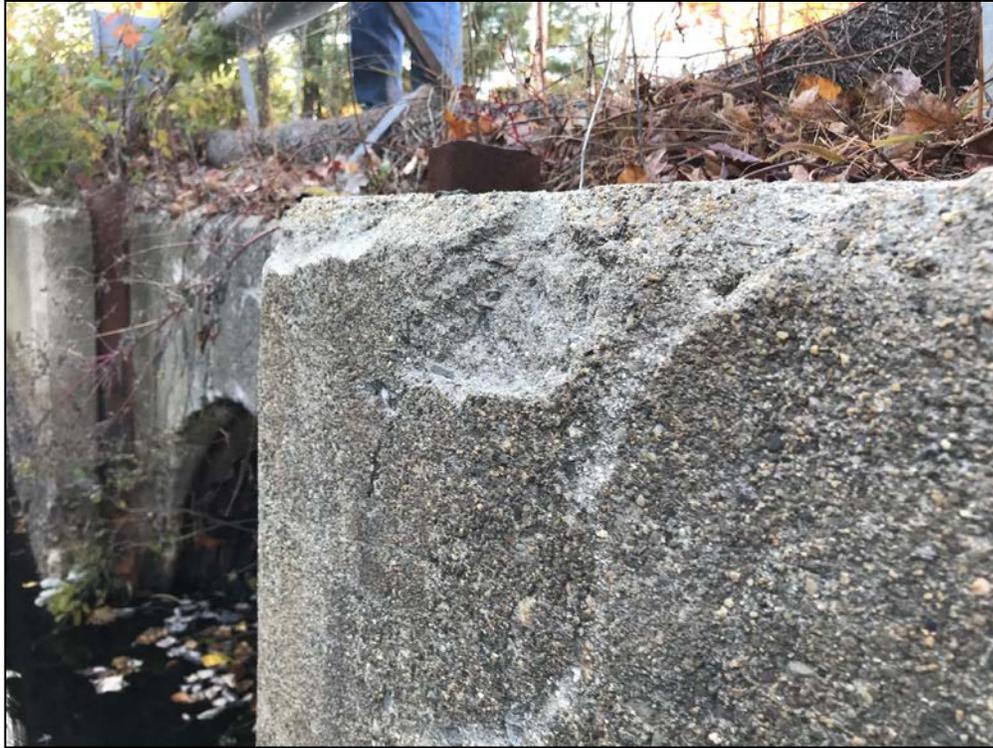
Photo No. 11: Left Outlet: Concrete chipping on the concrete headwall, the top right side of left outlet.

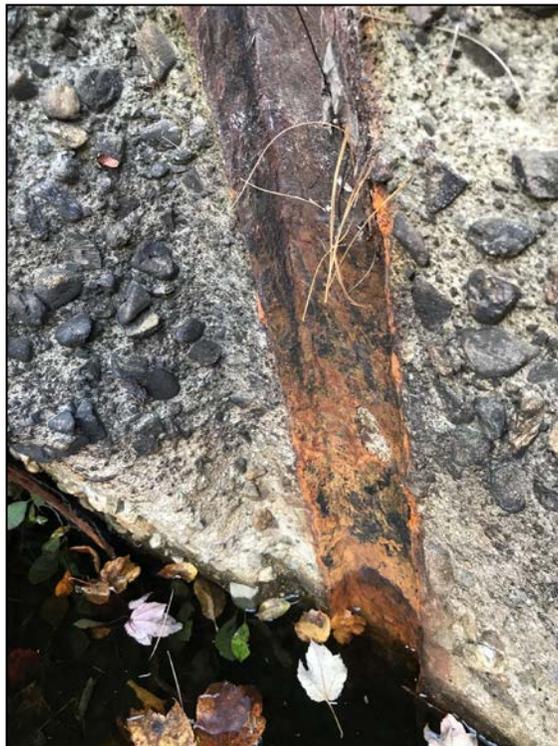
- Stop logs were not in place at the time of the inspection.
- The stop log slots are corroding and rusting.
- The upstream end of the CMP is bent left of its crown; but otherwise, in good condition.

Photo No. 12: Rusty and corroded stop log slots within the opening of the left outlet. Photo is of the right slot.

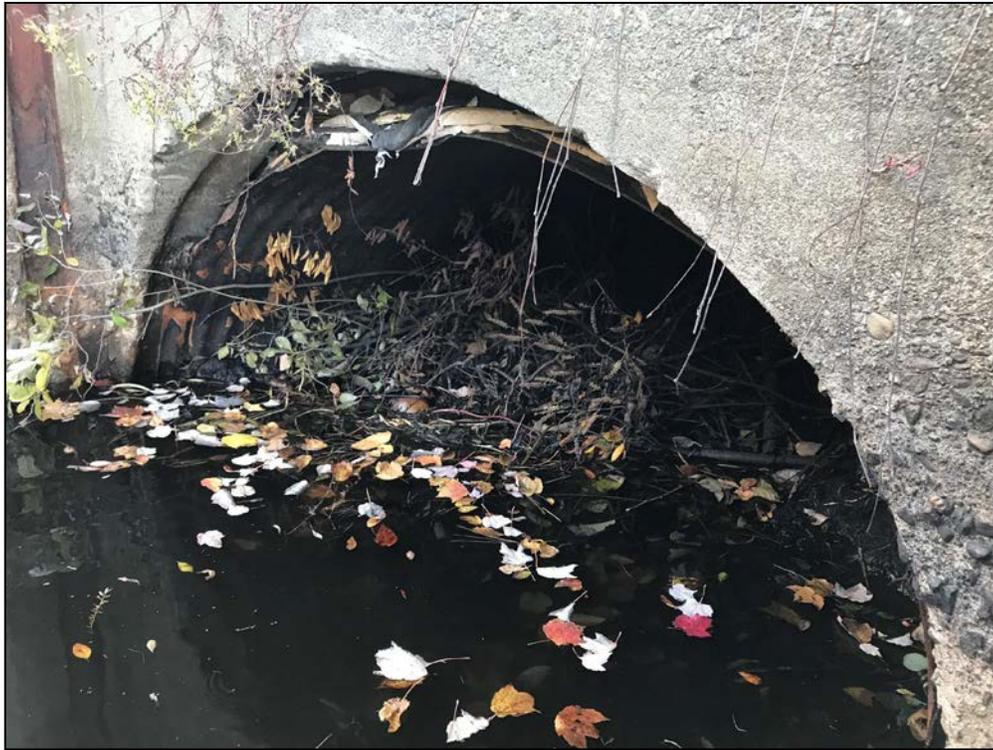
Photo No. 13: Vegetative debris in left outlet culvert entrance and concrete deterioration observed around the arch.

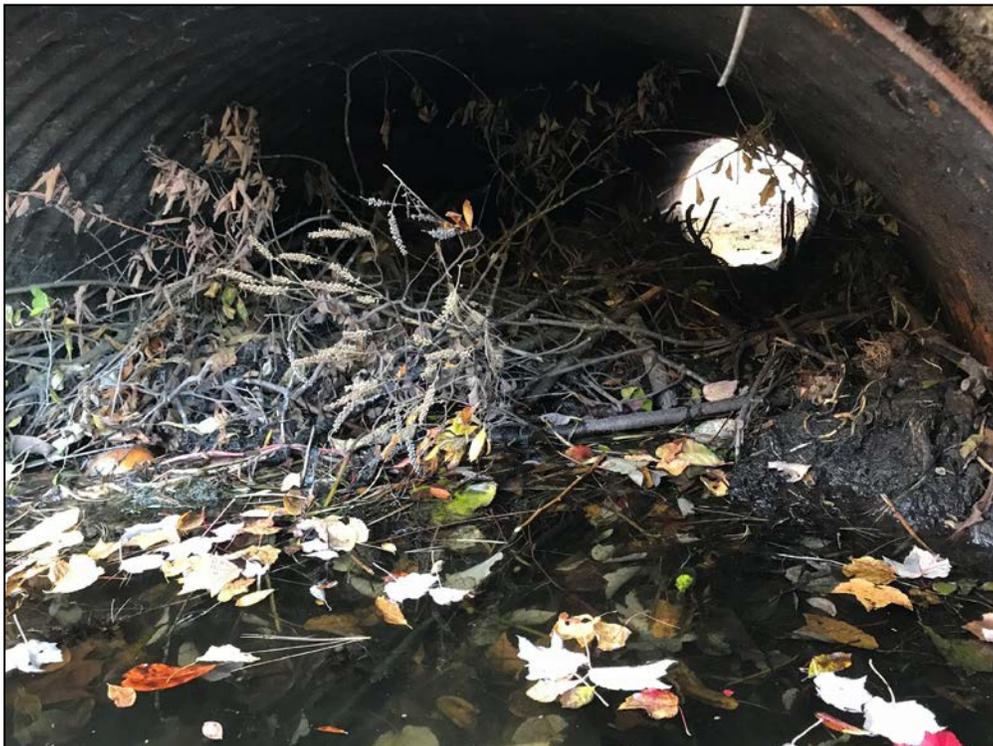
- Sediment buildup and woody debris is clogging the culvert. Reported beaver activity is most likely the cause of the buildup of branches and sticks.

Photo No. 14: Close up of accumulated debris (anticipated due to beavers) within the left outlet culvert.

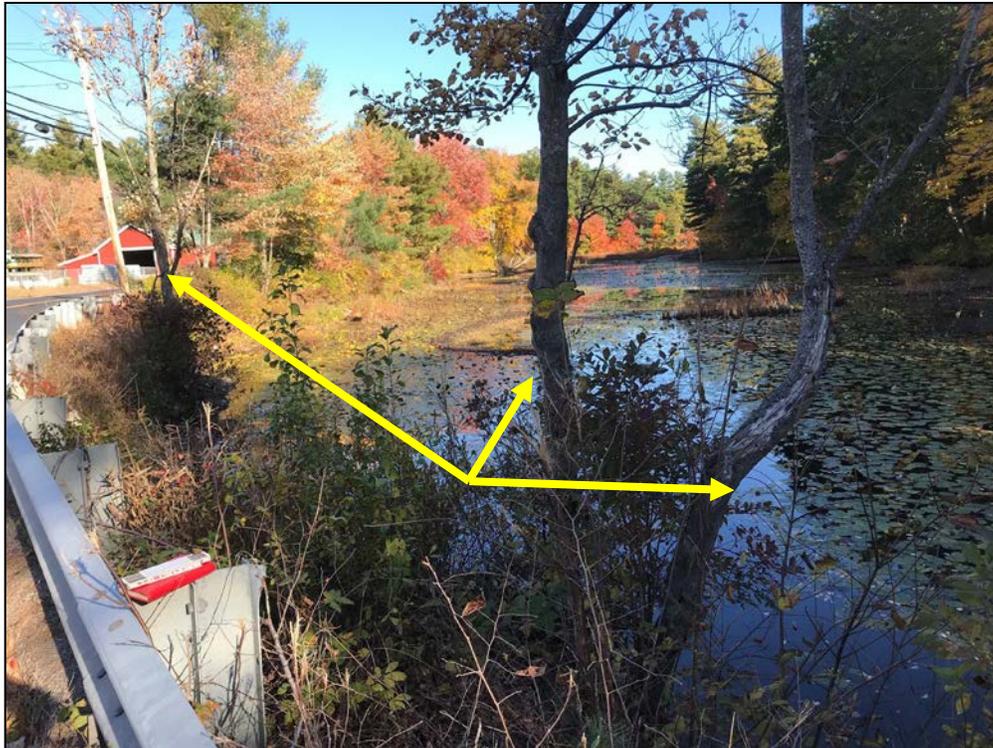
Photo No. 15: Woody vegetation and 6-inch diameter trees seen on both sides of the upstream slope of dam.

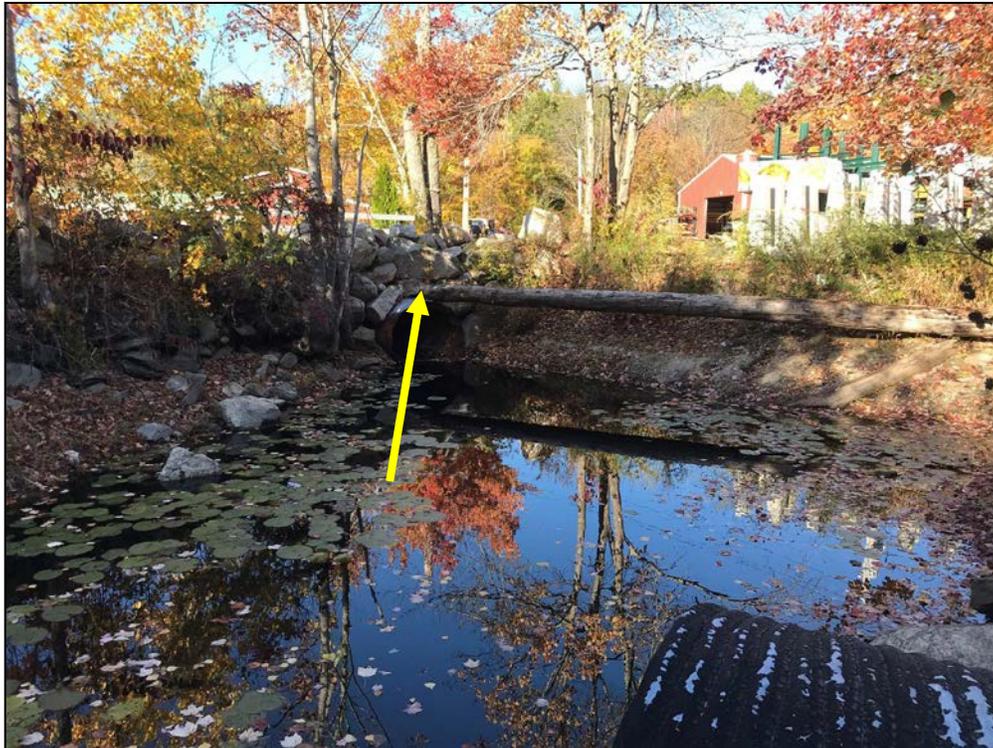
Photo No. 17: First tailwater pond as viewed from the left outlet discharge opening with telephone pole lying on top of culvert leading to the second tailwater pond.

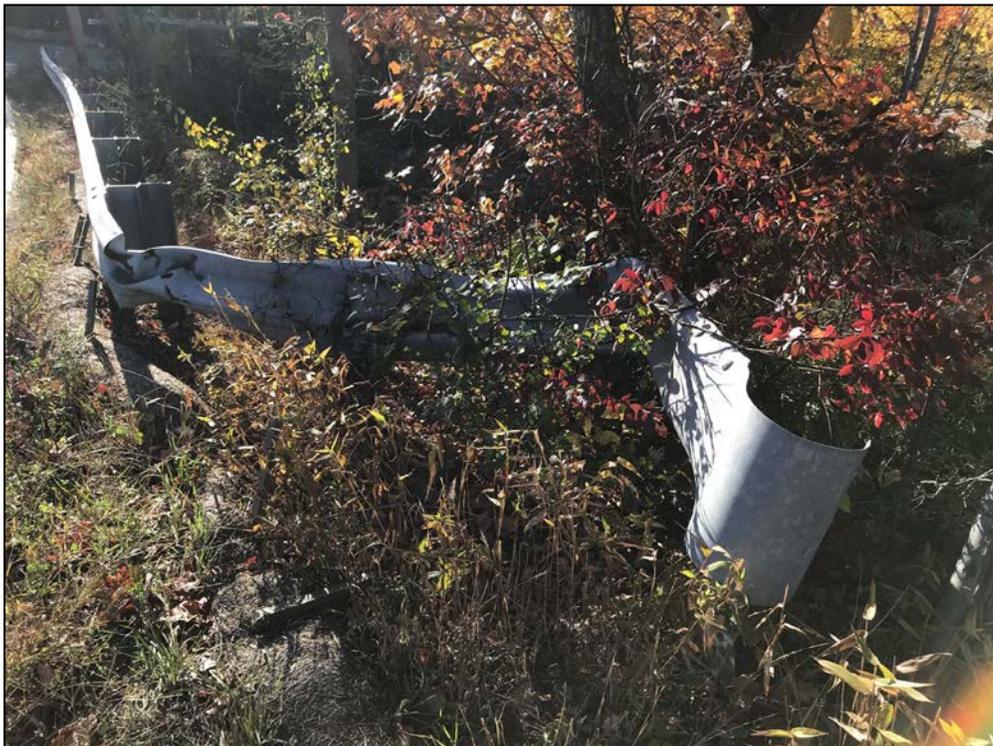
Photo No. 18: Damaged guardrail at STA 1+50.

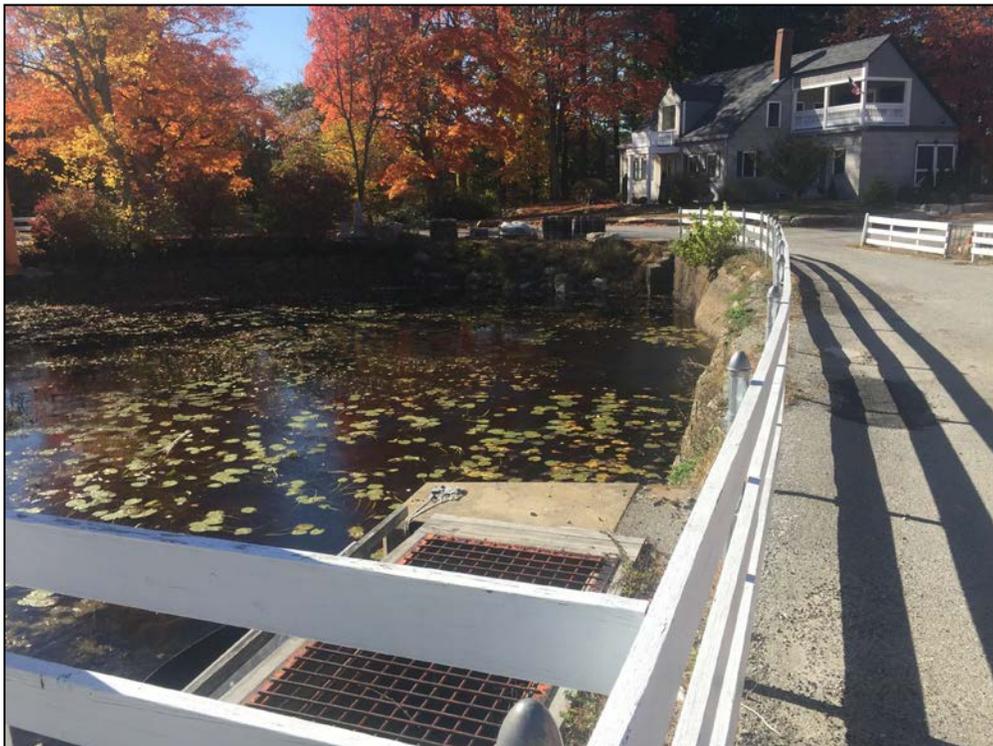
Photo No. 20: Upstream wall and roadway along crest of embankment impounding the second tailwater pond. Note vertical irregularity, patched depressions, and cracking on the roadway.

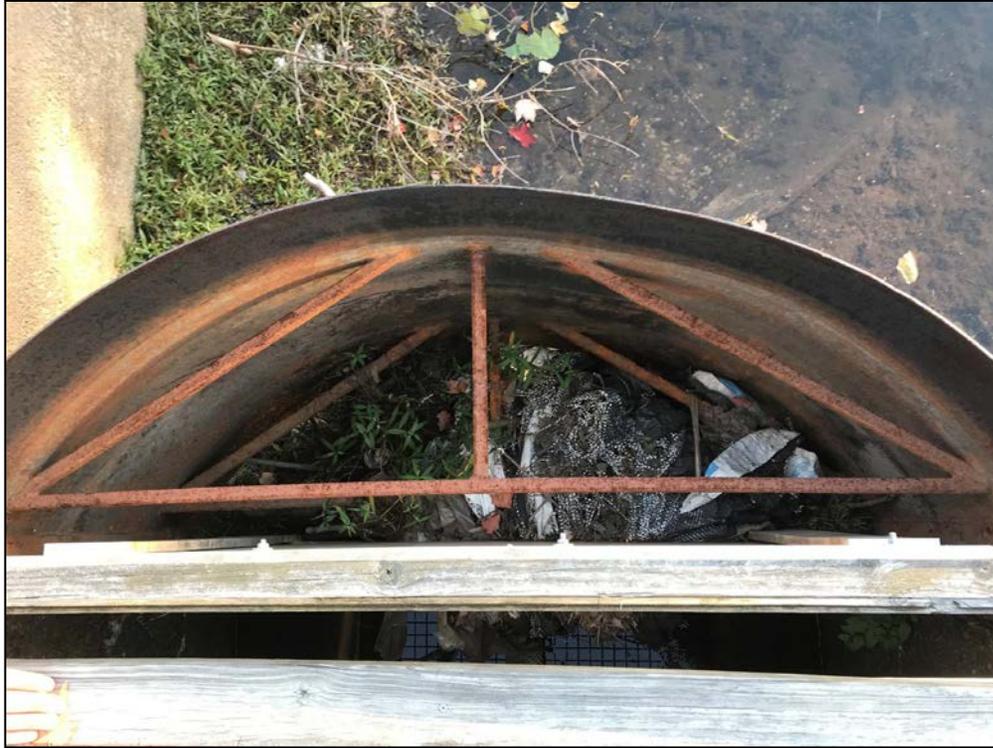
Photo No. 21: Second tailwater pond gated outlet with accumulated debris within the inlet.

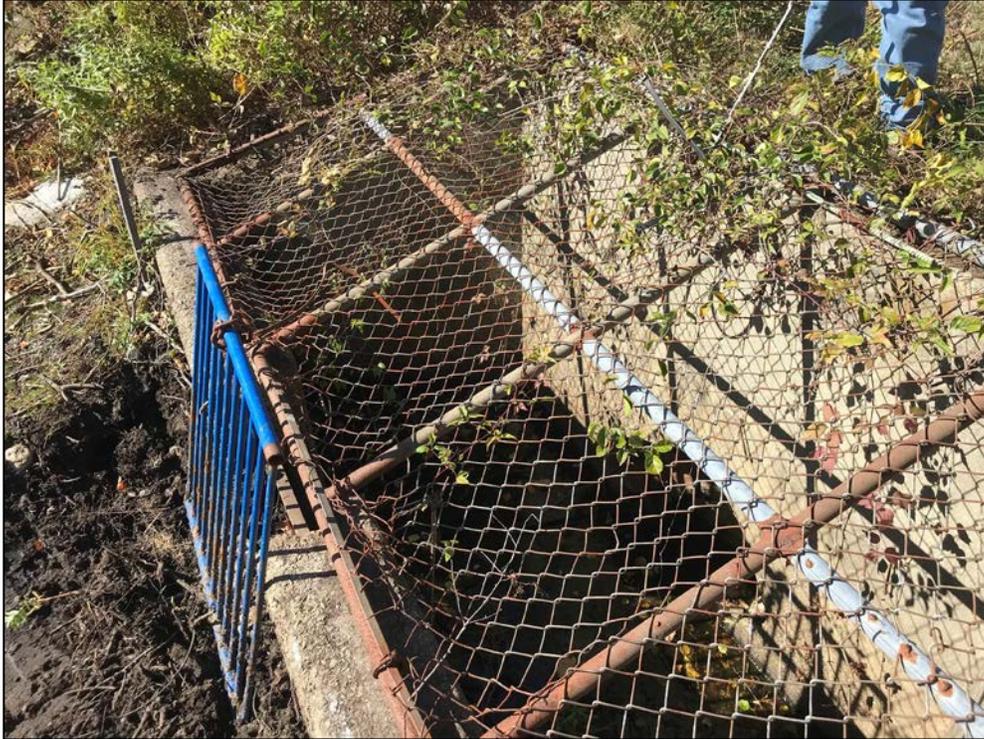
Photo No. 25: Brush growing around the right outlet concrete intake structure. The DPW crew recently cleared brush that had formed in front of the structure from beaver activity.
